**Flood Control Project Maintenance  
Levee Inspections**

**Fall 2011 Levee Maintenance Deficiency Summary Report**

**Reclamation District No. 0017 Mossdale**

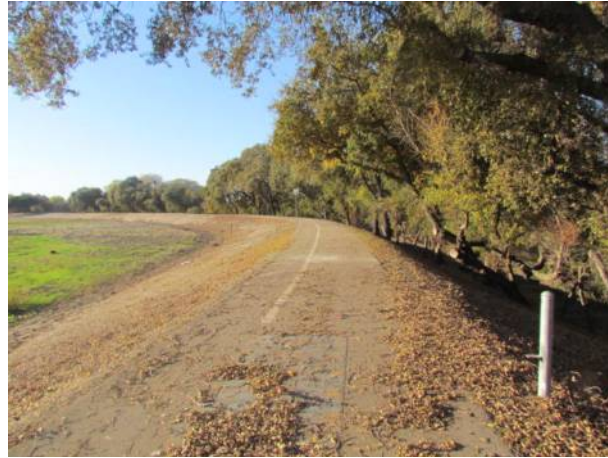
Levee Mile Report Line	1
Start Levee Mile	0.00
End Levee Mile	1.79
Location	Water Side
Category	Earthen Levee
Item	Vegetation

Looking north a at typical view of levee.

LMR No.	Levee Mile		Category	Item	Location *	Rating **	Action/Comment	GPS Latitude/Longitude		Issue No.
	Start	End						Start	End	Photo
1	0.00	1.79	Earthen Levee	Vegetation	WS	A	Remove the wild growth other than native grasses from the levee slopes.	°	°	7
								°	°	Y

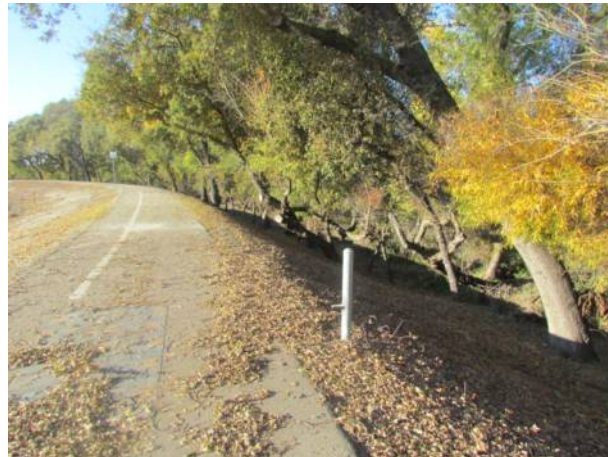
Levee Mile Report Line	1
Start Levee Mile	0.00
End Levee Mile	1.79
Location	Water Side
Category	Earthen Levee
Item	Vegetation

Looking north at well maintained trees on waterside of levee.

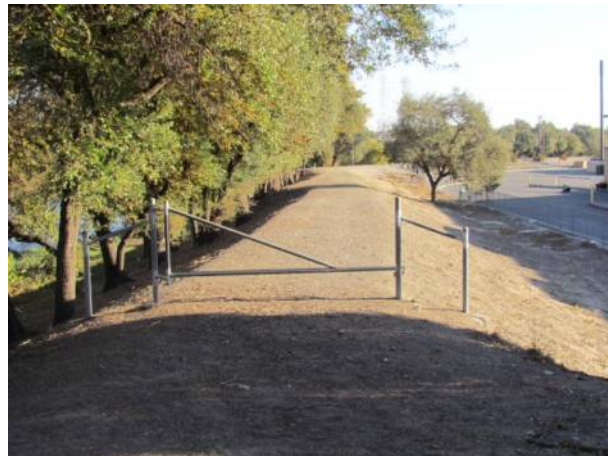
Levee Mile Report Line	1
Start Levee Mile	0.00
End Levee Mile	1.79
Location	Water Side
Category	Earthen Levee
Item	Vegetation

Looking south at well maintained trees and levee slope.

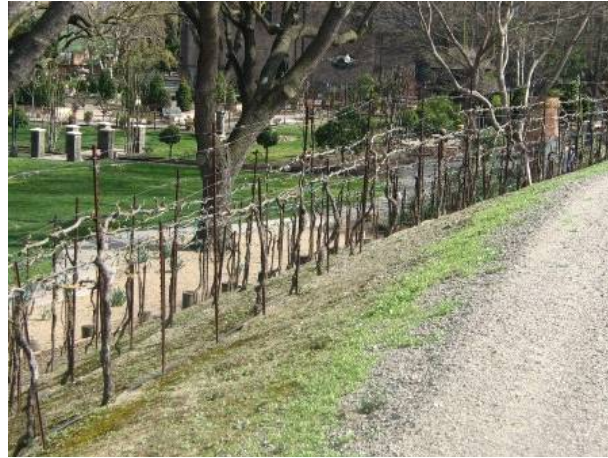
Levee Mile Report Line	6
Start Levee Mile	4.28
End Levee Mile	4.32
Location	Land Side
Category	Earthen Levee
Item	Encroachments
Grape vines on landside slope from LM 4.28 to 4.32	
richard_f_20111014_734.jpg

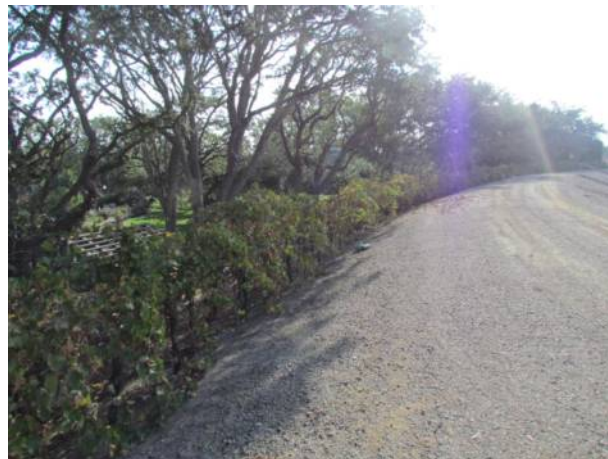
Levee Mile Report Line	6
Start Levee Mile	4.28
End Levee Mile	4.32
Location	Land Side
Category	Earthen Levee
Item	Encroachments
Looking southeast at grape vines on landside slope	
richard_f_20111027_331.jpg

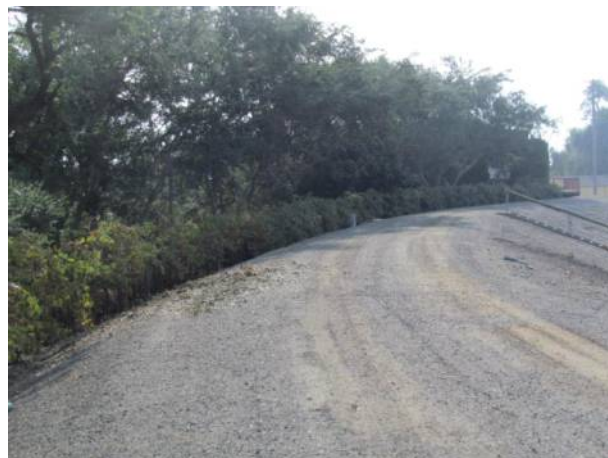
Levee Mile Report Line	6
Start Levee Mile	4.28
End Levee Mile	4.32
Location	Land Side
Category	Earthen Levee
Item	Encroachments
Looking south at landscaping with grape vines on landside slope	
richard_f_20111027_332.jpg

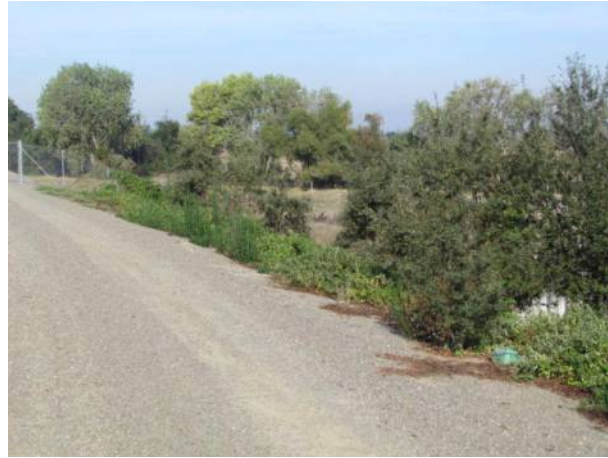
Levee Mile Report Line	6
Start Levee Mile	4.28
End Levee Mile	4.32
Location	Land Side
Category	Earthen Levee
Item	Encroachments

Looking northeast at dense landscaping on landside slope.

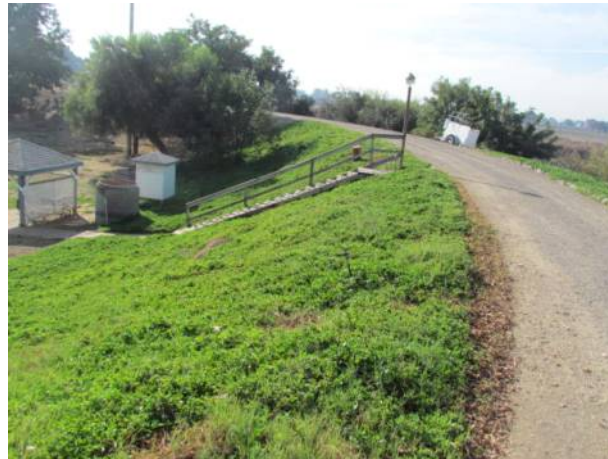
Levee Mile Report Line	7
Start Levee Mile	4.42
End Levee Mile	4.44
Location	Land Side
Category	Earthen Levee
Item	Encroachments

Looking southeast at ground cover on landside slope.

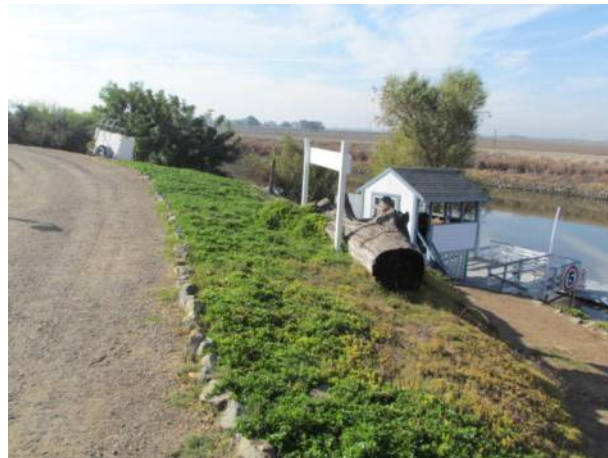
Levee Mile Report Line	7
Start Levee Mile	4.42
End Levee Mile	4.44
Location	Land Side
Category	Earthen Levee
Item	Encroachments

Looking southwest at landscaping and boat dock on waterside slope and channel.

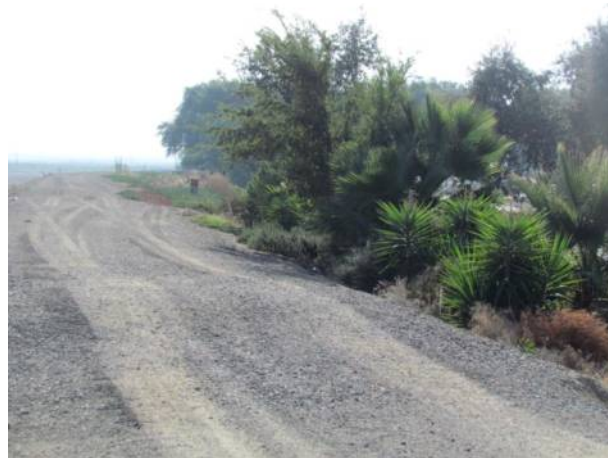
Levee Mile Report Line	12
Start Levee Mile	5.62
End Levee Mile	5.85
Location	Land Side
Category	Earthen Levee
Item	Encroachments

Looking south at overgrown landscaping on waterside slope.

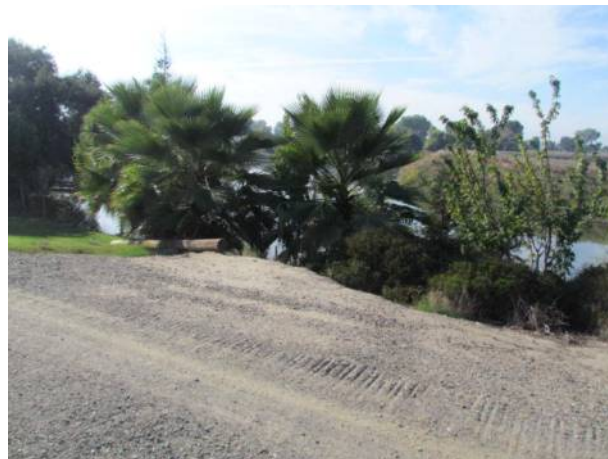
Levee Mile Report Line	12
Start Levee Mile	5.62
End Levee Mile	5.85
Location	Land Side
Category	Earthen Levee
Item	Encroachments

Looking west at landscaping on waterside slope.

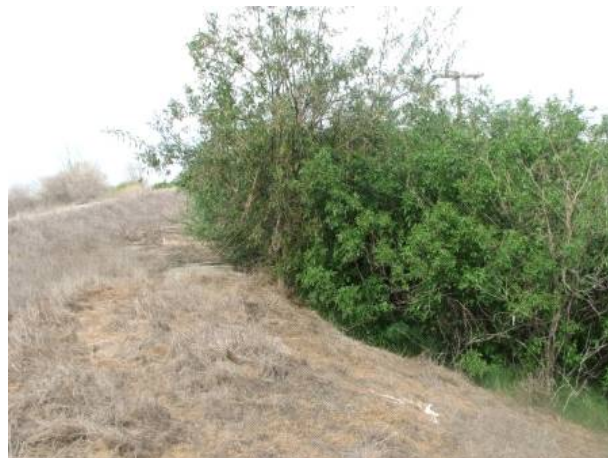
Levee Mile Report Line	15
Start Levee Mile	7.67
End Levee Mile	7.69
Location	Land Side
Category	Earthen Levee
Item	Vegetation

Elderberry blocking view of landside slope and toe from LM 7.67 to 7.69
